## Strategy and Assets Committee

ULLADULLA SKATE PARK AUDIT REPORT

DOCUMENT: ULLADULLA SKATE PARK AUDIT REPORT

REF: 18042

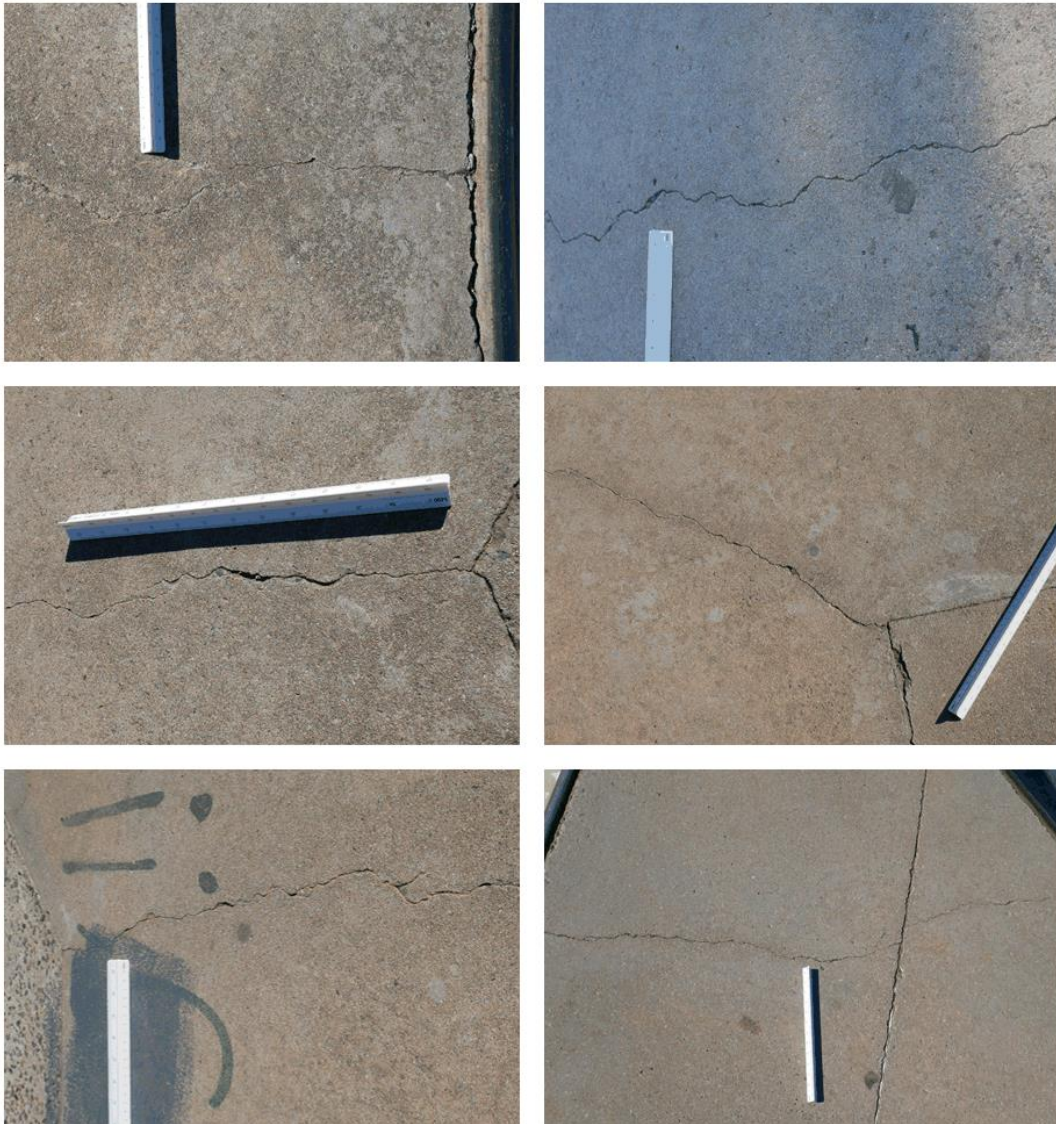
### CONDITION ASSESSMENT - MINOR CRACKING

#### MINOR CRACKING:

The concrete slabs are showing signs of minor cracking in a number of locations across the facility. This cracking could be due to earth movement, incorrect construction techniques employed during the initial build, or general deterioration due to the age of the concrete. While currently minor, if left unaddressed the cracking has the potential to develop further, resulting in major cracking, or leading to an uneven skate surface that is prone to chipping.

WATER PONDING	HAZARD DETERIORATION AGE	HIGH	DEMOLISH BASE SLAB. REINSTATE BASE SLAB WITH CORRECT GRADE TO DRAIN OFF SKATE SURFACE.	6 MONTHLY	1 - 2 MONTHS
LOW PRIORITY ITEMS					
MINOR CRACKING	DETERIORATION AGE	LOW	SPECIALIST CRACK INJECTION REPAIRS.	6 MONTHLY	6 MONTHS

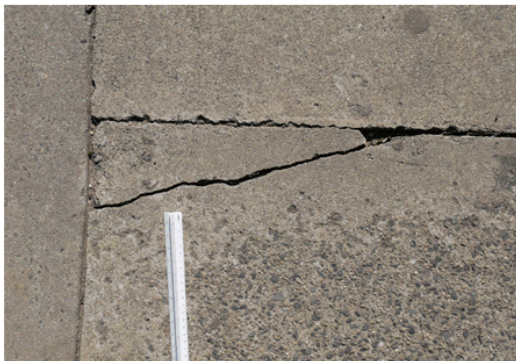
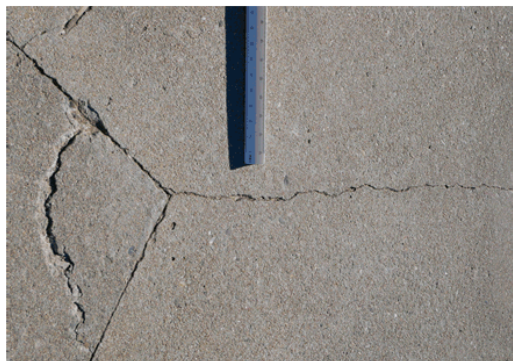
**CONDITION ASSESSMENT - MAJOR CRACKING**

**MAJOR CRACKING:**

There are some incidence of major cracking in a number of locations across the facility. Major cracks present a hazard on the skate area where the smaller wheels of scooters and skateboards can become lodged in the cracks while the user is travelling at speed, consequently throwing the rider off their vehicle. Unexpectedly being thrown while travelling at speed has the potential to result in serious harm to the user.

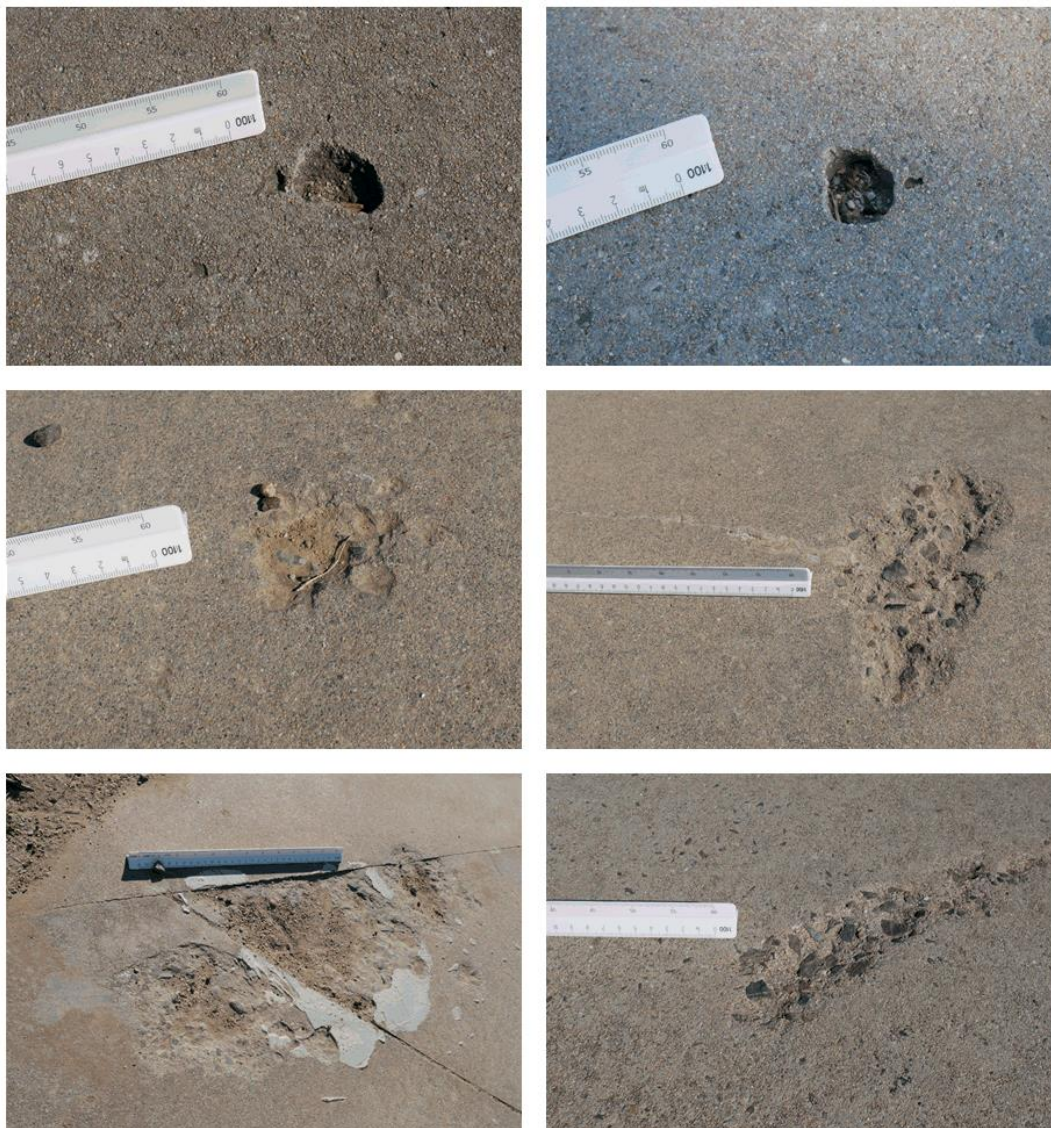
**CONDITION ASSESSMENT - SURFACE CHIPPING**

**SURFACE CHIPPING:**

The concrete slabs have a number of areas suffering from surface chipping. Chipping is the result of wear and tear from general use, and is common in parks of this age. Surface chipping presents a hazard on the skate area where the smaller wheels of scooters and skateboards can become lodged while the user is travelling at speed, consequently throwing the rider off their vehicle. Unexpectedly being thrown while travelling at speed has the potential to result in serious harm to the user.

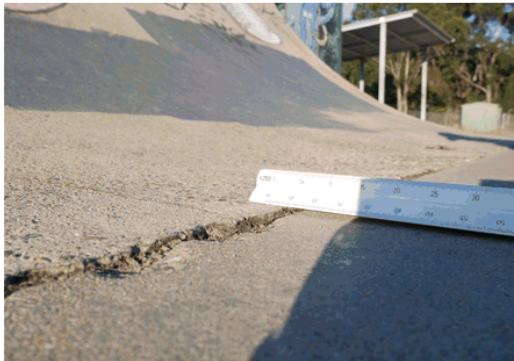
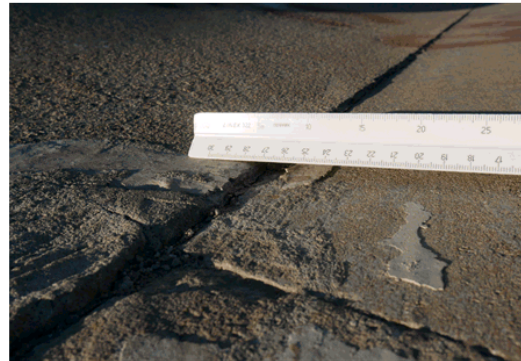
**CONDITION ASSESSMENT - DIFFERENTIAL SETTLEMENT**

**DIFFERENTIAL SETTLEMENT:**

Differential settlement occurs where a slab has shifted either horizontally or vertically, independent of the adjacent slabs. This results in an edge at the abutment of the two slabs, and presents an opportunity for scooter or skateboard wheels to catch on the edge. Differential settlement in this case has occurred at the base of the vert wall, and in the transition of the deep bowl. These locations are where users are travelling at speed, and as such the potential for harm to users is high.

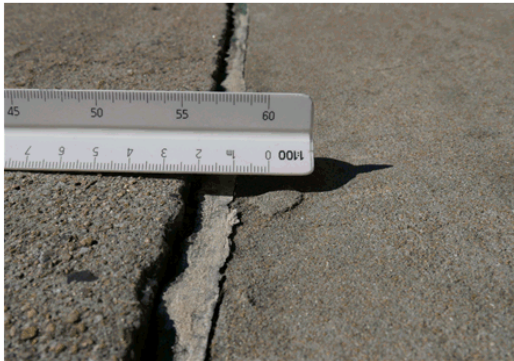
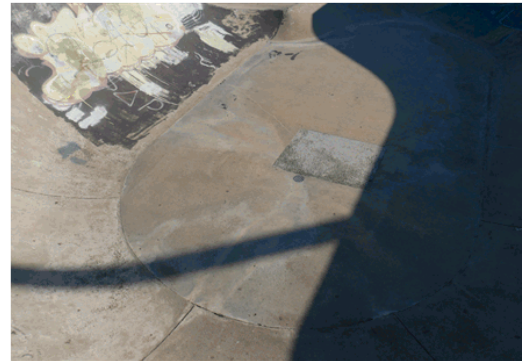
**CONDITION ASSESSMENT - STRUCTURAL DISPLACEMENT**

**STRUCTURAL DISPLACEMENT:**

Evidence of groundwater forces is prominent in the large bowl. Water stains emanating from the joint between transition toe and base suggests that significant ground water flows are present in the area up hill of the facility. It is assumed that the ground water is causing swelling of the surrounding ground, which in turn is displacing the transition slabs in the bowl. Surface water on the skate area, coupled with displaced structural elements presents a major risk item to users. Investigations into the origins of the groundwater should be undertaken, with rectification works addressed immediately.

ITEM DESCRIPTION	CAUSE OF DEFECT	PRIORITY OF WORKS	REQUIRED ACTION	RECOMMENDED MONITORING REQUIREMENTS	RECOMMENDED ACTION TIME FRAME
HIGH PRIORITY ITEMS					
STRUCTURAL DISPLACEMENT	HAZARD DETERIORATION AGE	HIGH	DEMOLISH BASE OF BOWL AND AFFECTED TRANSITION SLABS. INSTALL SUB SURFACE DRAINAGE IN TRANSITION SURFACE AND IN BASE OF BOWL, TO DRAIN BACK TO EXISTING BOWL DRAIN. REINSTATE BOWL AND TRANSITION SLABS.	6 MONTHLY	1-2 MONTHS
MAJOR CRACKS	HAZARD DETERIORATION AGE	HIGH	CHASE OUT CRACK, CLEAN RECESS, FILL WITH MULTI-PURPOSE EPOXY ADHESIVE REPAIR PASTE, AND SAND BACK SMOOTH TO EXISTING SURFACE LEVELS.	6 MONTHLY	1-2 MONTHS
SURFACE CHIPPING	HAZARD DETERIORATION AGE	HIGH	GRIND BACK CHIPPED EDGE, CLEAN OF ALL DEBRIS AND DUST, FILL WITH MULTI PURPOSE ADHESIVE REPAIR PASTE, AND SAND BACK SMOOTH TO EXISTING SURFACE LEVELS.	6 MONTHLY	1-2 MONTHS
DIFFERENTIAL SETTLEMENT	HAZARD	HIGH	GRIND BACK CONCRETE SURFACE OF HIGHER SIDE OF SLAB TO SMOOTH AND TAPERED FINISH, ALLOWING SURFACE TO SMOOTHLY GRADE BETWEEN LEVELS.	6 MONTHS	IMMEDIATELY

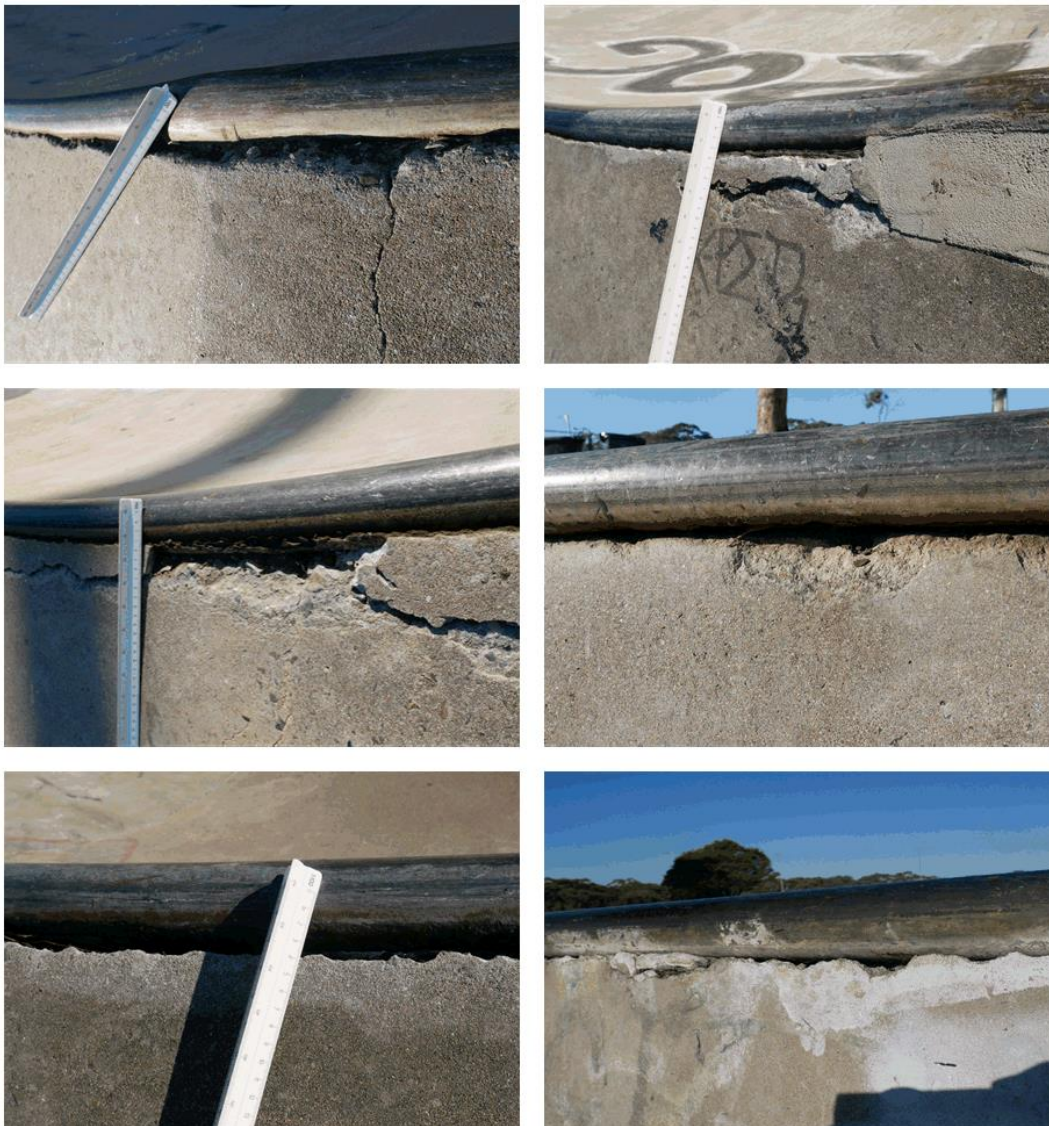
**CONDITION ASSESSMENT - CONCRETE TO COPING JOIN (CHS)**

**CONCRETE TO COPING JOIN (CHS):**

The transition and platform concrete adjacent to the circular coping on the bowls and quarter pipes is severely deteriorated. In the deep end of the bowl the coping is rusted through, exposing sharp edges. The coping is necessary in these locations for users to perform tricks on, often at speed, and due to the depth of the features, at height. The deterioration of the concrete and coping in these areas presents the opportunity for scooters, skateboards, and BMX pegs to become lodged in the rough concrete, consequently throwing a rider off their vehicle. The condition of the coping in the bowl is a high risk item, and should be addressed immediately.

CONCRETE TO COPING JOIN (CHS)	HAZARD DETERIORATION AGE	HIGH	SAW CUT AND CHIP AWAY CRACKS, REINSTATE SURFACE PROFILE WITH REINSTATEMENT MORTAR, STRIKE OFF LEVEL WITH SURROUNDING CONCRETE SURFACE, STEEL TROWEL FINISH. REPLACE COPING IN LOCATIONS WHERE RUSTED AND DETERIORATED.	6 MONTHLY	IMMEDIATELY
COPING TOLERANCE	INCORRECT CONSTRUCTION	HIGH	SAW CUT AND DEMOLISH PLATFORM AND TRANSITION SLAB 200mm EITHER SIDE OF COPING. INSTALL NEW ROLLED COPING TO ACCEPTABLE TOLERANCES AND TIE INTO EXISTING SLABS. POUR NEW CONCRETE TO COPING, ENSURING TRANSITION RADII AND STANDARD ACCEPTABLE OFFSETS ARE MAINTAINED.	6 MONTHLY	1-2 MONTHS
HAZARDOUS CONCRETE JOINT	HAZARD DETERIORATION AGE	HIGH	CHASE OUT JOINT, CLEAN RECESS, FILL WITH MULTI-PURPOSE EPOXY ADHESIVE REPAIR PASTE, AND SAND BACK SMOOTH TO EXISTING SURFACE LEVELS.	6 MONTHLY	IMMEDIATELY
ROUGH SKATE SURFACE AREA	HAZARD DETERIORATION AGE	HIGH	GRIND BACK CONCRETE SLABS TO REMOVE ROUGH SURFACE, ENSURE GRINDED AREAS ARE FEATHERED EVENLY TO MEET SURROUNDING SURFACE LEVELS TO ENSURE NO KINKS OR BUMPS IN RIDING SURFACE.	6 MONTHLY	1 - 2 MONTHS

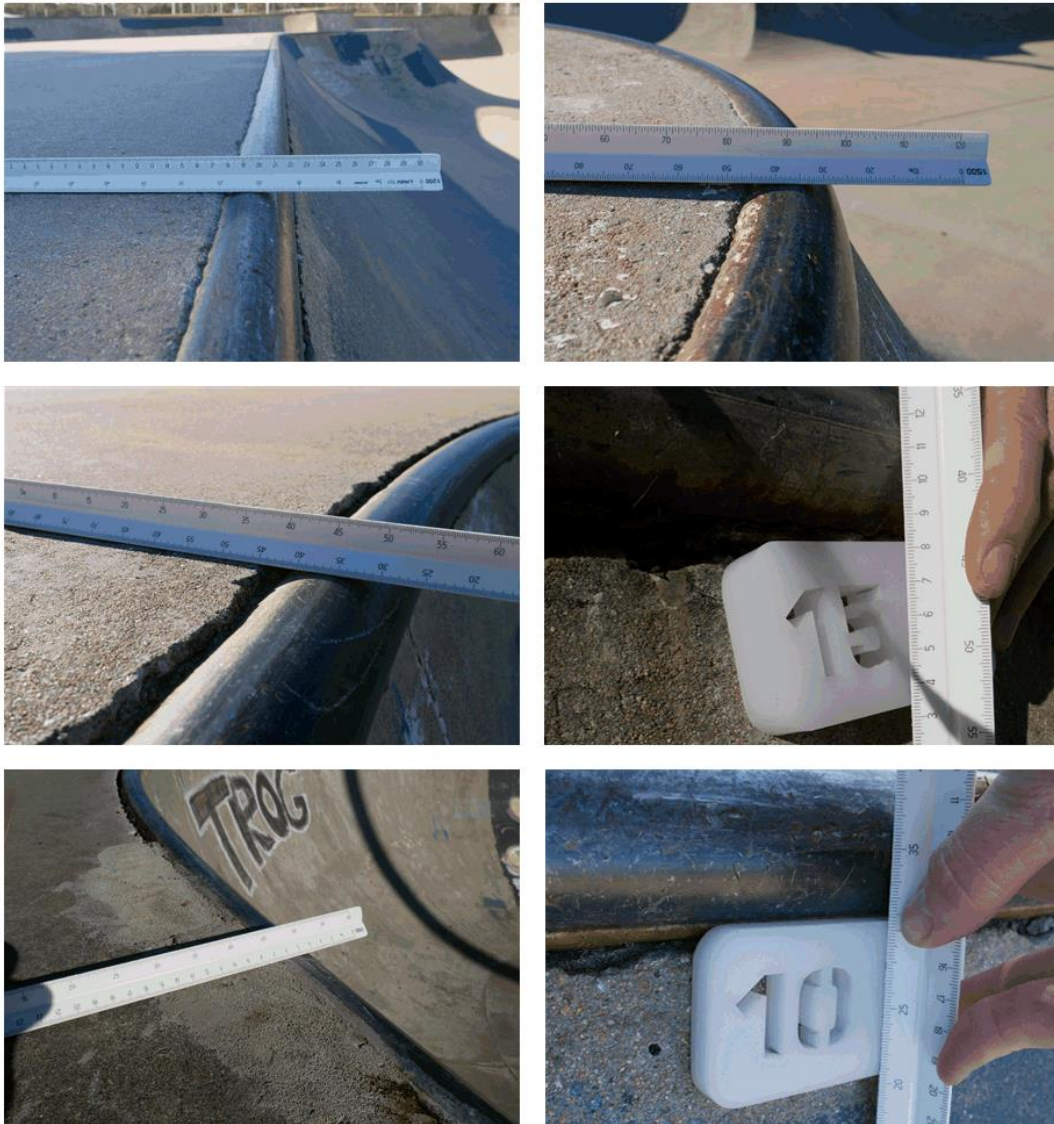
**CONDITION ASSESSMENT - COPING TOLERANCE**

**COPING TOLERANCE:**

The coping offsets around the facility are not in line with modern practices. Typically, coping should sit 10mm above ramp platforms, and sit proud 8mm off ramp transition faces. These standard offsets dimensions are set to encourage coping tricks, and to allow smooth use of the transition ramps. Across most of the facility, the coping sits flush with the platform level, while transition offsets vary from 10mm to approximately 25mm. This inconsistency across the facility doesn't promote user confidence in the terrain of the features.

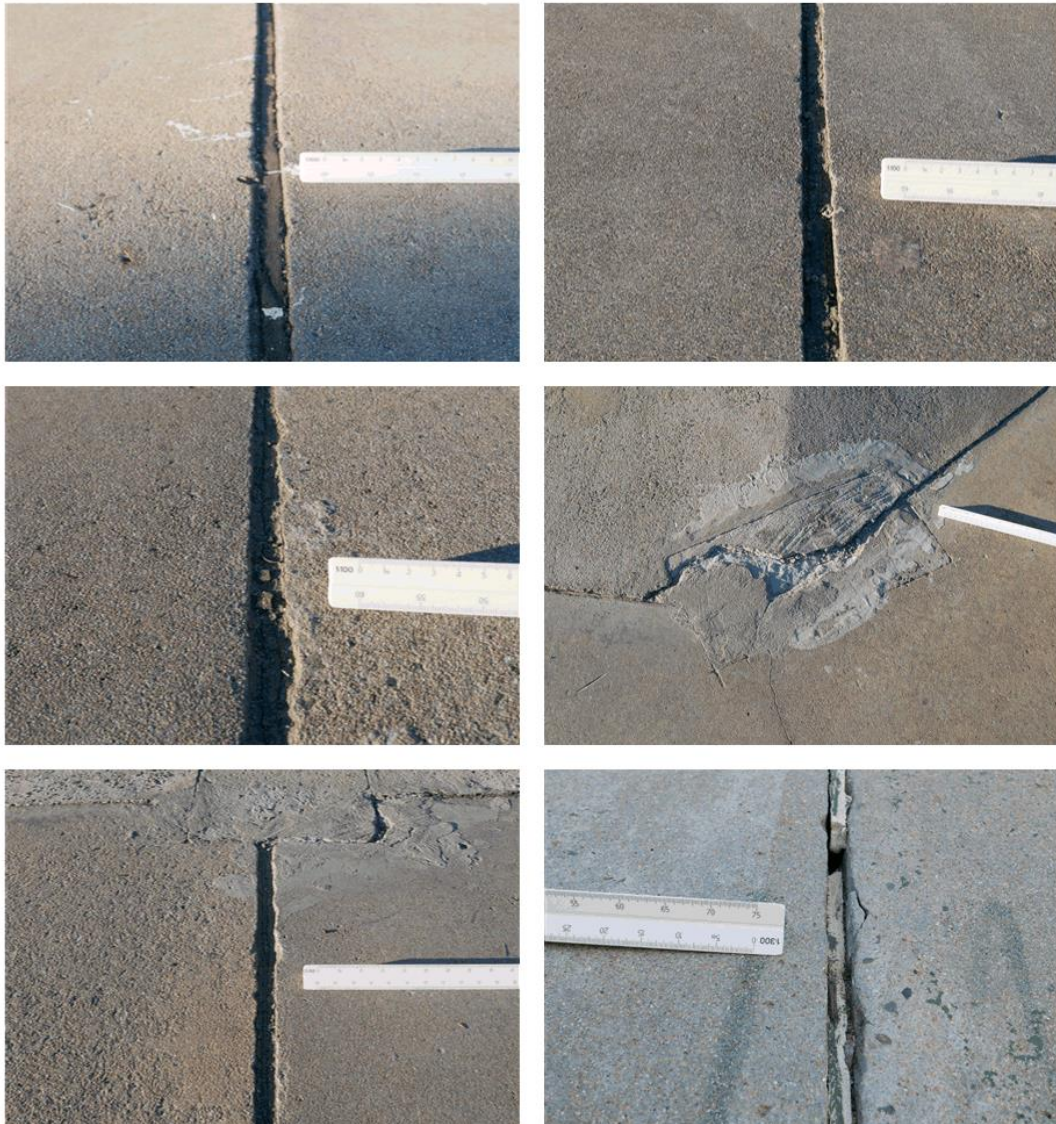
**CONDITION ASSESSMENT - HAZARDOUS CONCRETE JOINT**

**HAZARDOUS CONCRETE JOINT:**

Expansion joints across the facility have enlarged over time, and grown to as wide as 20mm in some instances. Furthermore, due to repetitive impact action from skateboard wheels, the edges of these joints are showing signs of deterioration and chipping. Wide joints present a hazard on the skate area where the smaller wheels of scooters and skateboards can become lodged while the user is travelling at speed, consequently throwing the rider off their vehicle. Unexpectedly being thrown while travelling at speed has the potential to result in serious harm to the user.

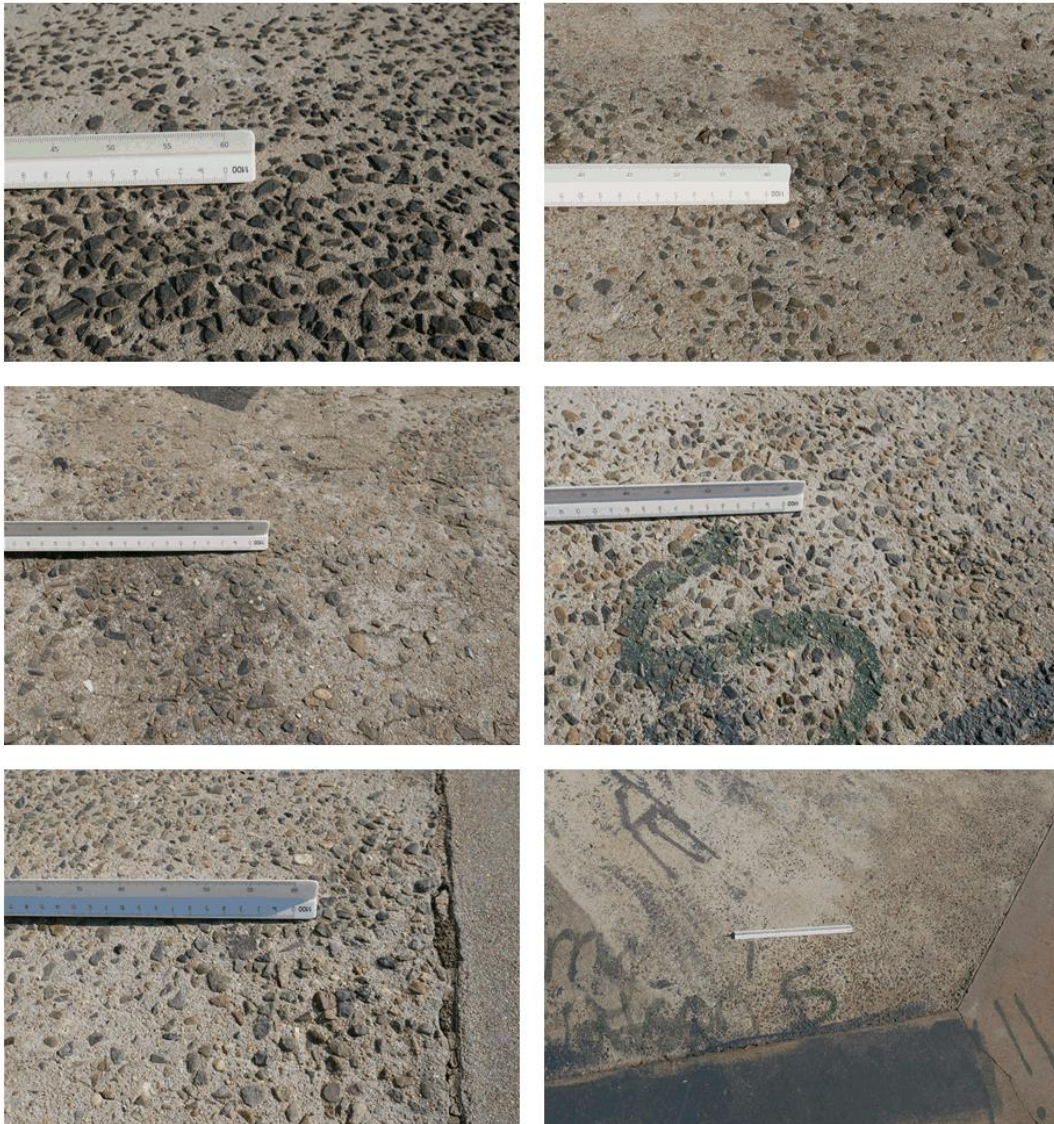
**CONDITION ASSESSMENT - ROUGH SKATE SURFACE AREA**

**ROUGH SKATE SURFACE AREA:**

In a number of locations, the skate slab has become weathered and worn, exposing the aggregate in the concrete. Furthermore, there are locations where repairs and patches to the slab have been undertaken, which are in turn degrading. It is imperative that skate surfaces are smooth, as rough areas result in a bumpy and jarring sensation when ridden over, while also presenting an abrasive surface that can cause harm when a user comes into contact. This is a high priority item and should be addressed immediately.

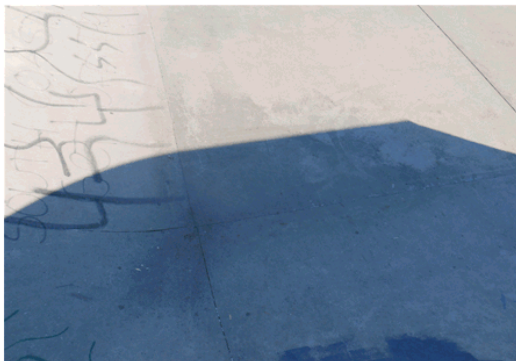
**CONDITION ASSESSMENT - WATER LEAKING / PONDING**

**WATER PONDING:**

Despite the weather on the day of inspection being warm and sunny, there is evidence of water ponding on the skate surface. There is water staining present on the southern side of the spine ramp. Local users informed that water remains present in that location for long periods of time after rain events, suggesting that the slab in that area of the facility is not properly graded to deal with wet weather events. Wet skate surfaces are a hazard due to users slipping out at high speeds. The causes for the water seepage and ponding should be investigated and addressed immediately.

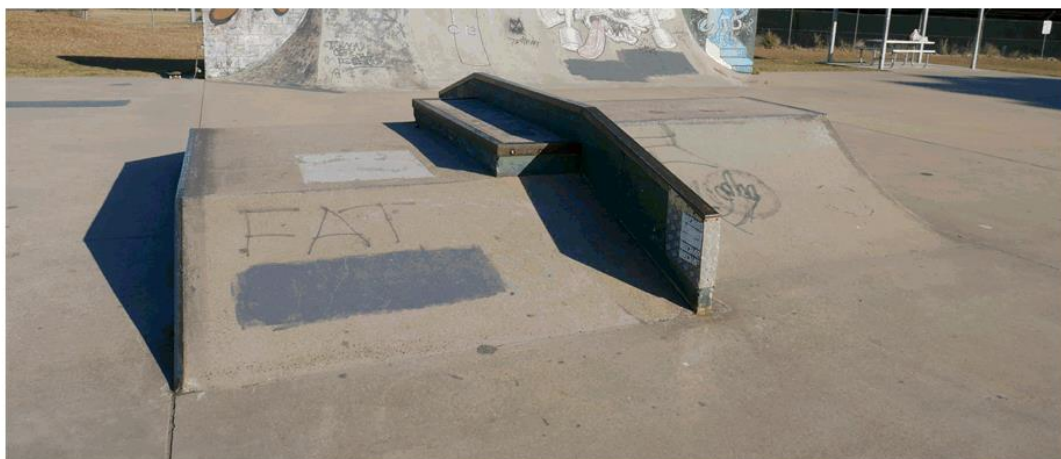
**OUTDATED FUN BOX DESIGN**

The fun box located near the vert wall is out dated and not designed to modern skate practices. The small ledge is set too low, and doesn't extend into the flat bank transition. The rail is too low and is only able to be accessed from one side, and is essentially unusable due to being positioned adjacent to other features. Minor repairs on the rail and ledge have left exposed sharp metal edges, which will cause serious harm if a user is to come into contact with them.

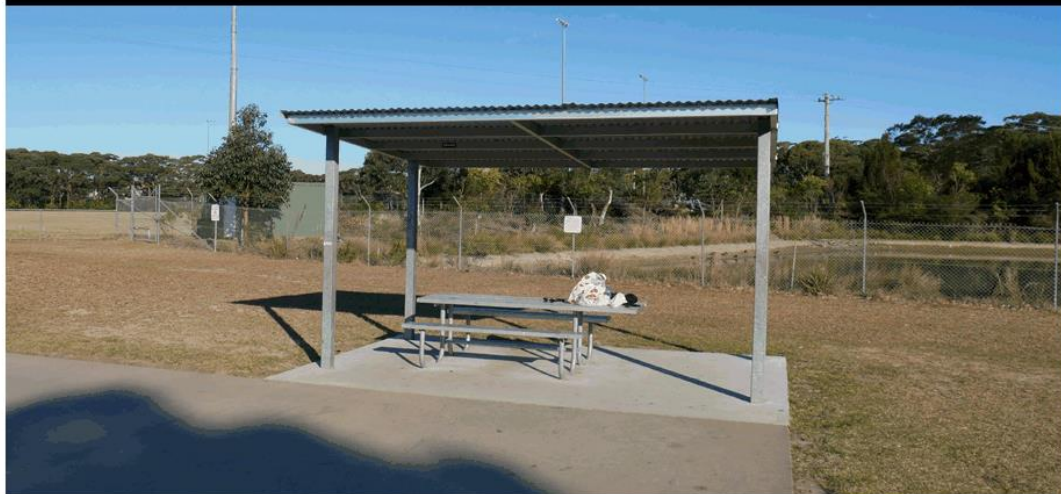
**SHADE, SEATING AND REFUGE**

There is a small shelter at the southern edge of the park which provides minimal shade and seating. Other than this shelter, there is little to no shade or seating available to users. It is important to provide users with adequate seating options, as well as ample shade to escape the sun. At the time of inspection the shelter was not casting shade onto the seating below.

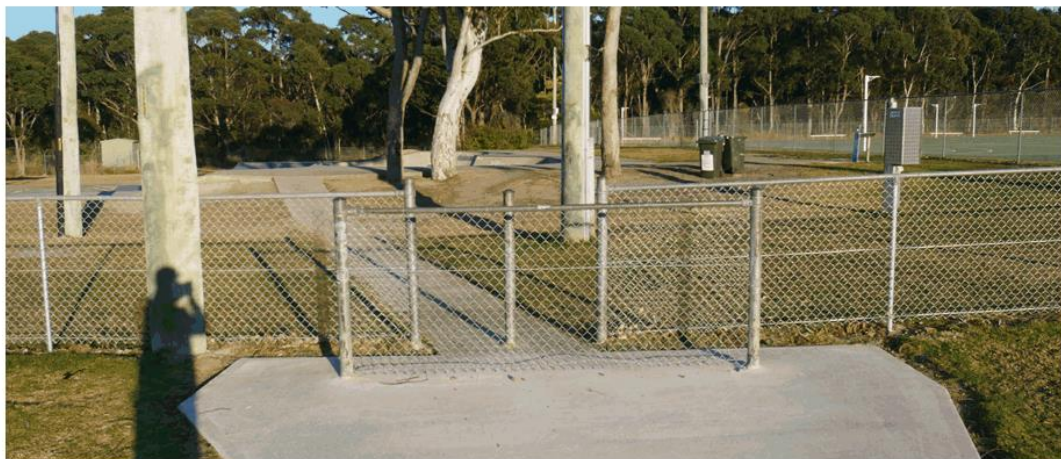
**FENCING AND LIMITED ACCESS**

The facility is surrounded by fencing, with access limited by a staggered fence treatment. Furthermore, the facility is set back from the fence and car park. This gives the facility an "exclusive" and "back of house" feel, and doesn't encourage passive users to enter.

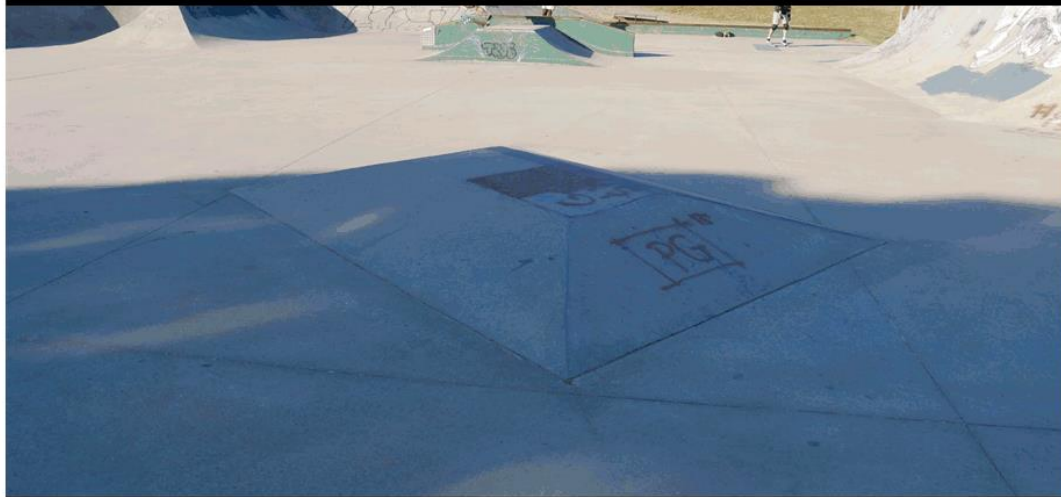
**LIMITED OPPORTUNITY FOR BEGINNERS**

The facility caters to both intermediate and advanced users, with little to no opportunity for beginners. This does not allow for new users to the to practice or increase skill levels, and encourages less skilled users to use the more advanced areas of the facility. This can lead to collisions with more advanced users.

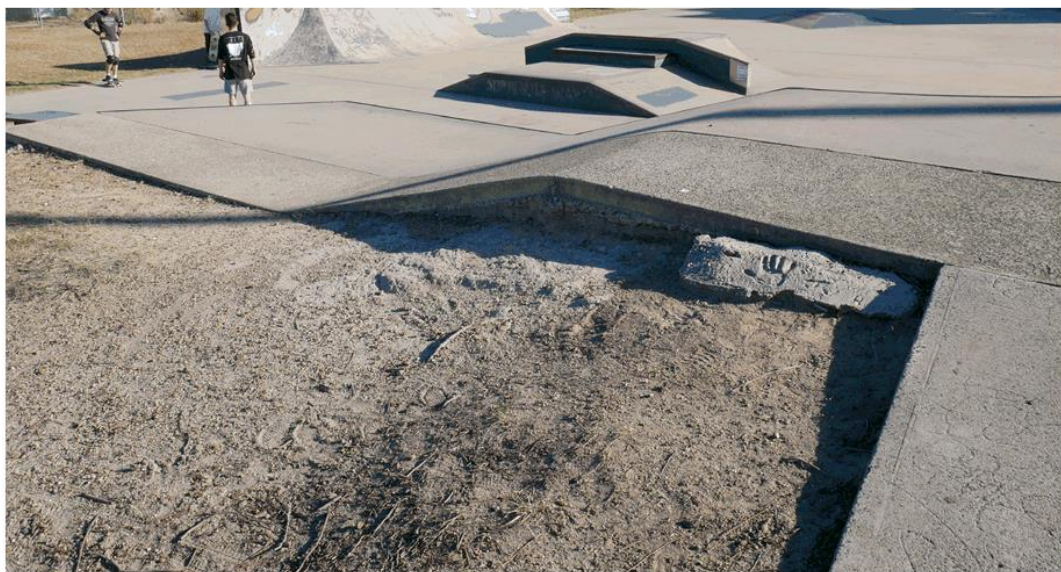
**SITE EROSION**

Erosion is present around the perimeter of the facility, with some evidence of previous repairs. The underside of the concrete slab is exposed, with the surrounding area being predominantly exposed dirt. This encourages dust and dirt to be introduced to the skate area, which in turn creates a slippery concrete surface. Larger dirt and stone particles also present the risk of becoming jammed under rider's wheels.

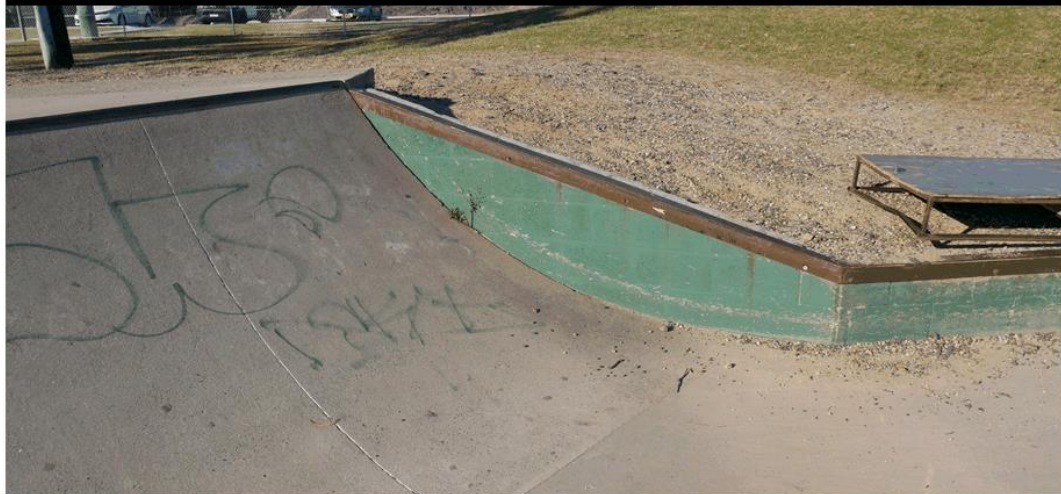
**REDUNDANT LEDGE**

There is a ledge with coping edge running adjacent to the quarter pipe on the eastern side of the facility. There is no run up for this feature for it to be used as a ledge, and its presence next to the quarter pipe presents a distraction to users using said quarter pipe. The coping on the ledge is rusted, misshapen, and exposed, and presents a risk to users using this feature.

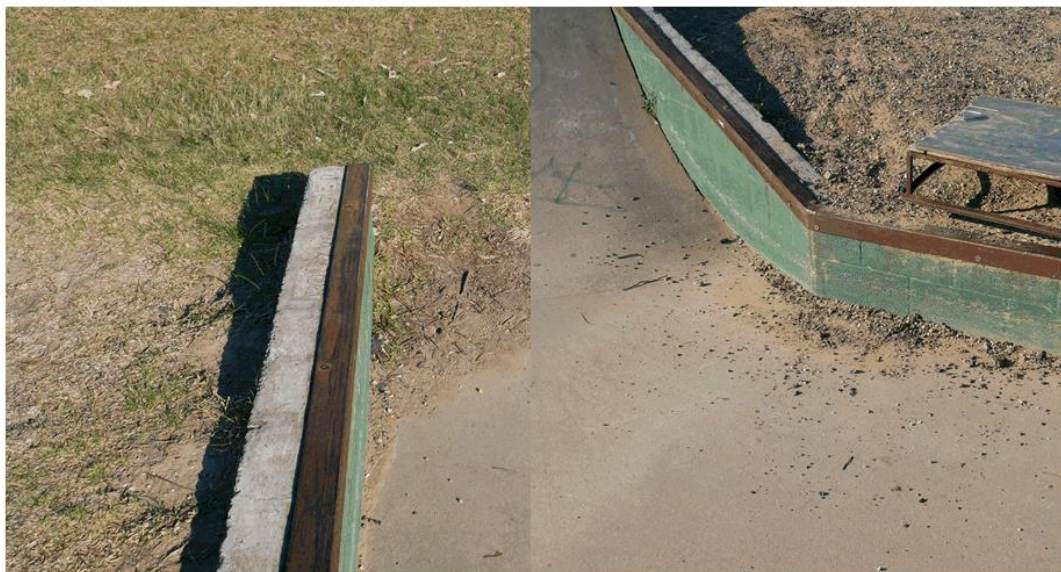
**DEBRIS ON SKATE SURFACE**

Debris is spilling on to the skate surface from the adjacent landscaped area. Dirt, sticks, and small rocks present a risk to users where wheels can become jammed on the debris while at high speed. Regular maintenance on the facility should include sweeping and cleaning all skate surfaces.

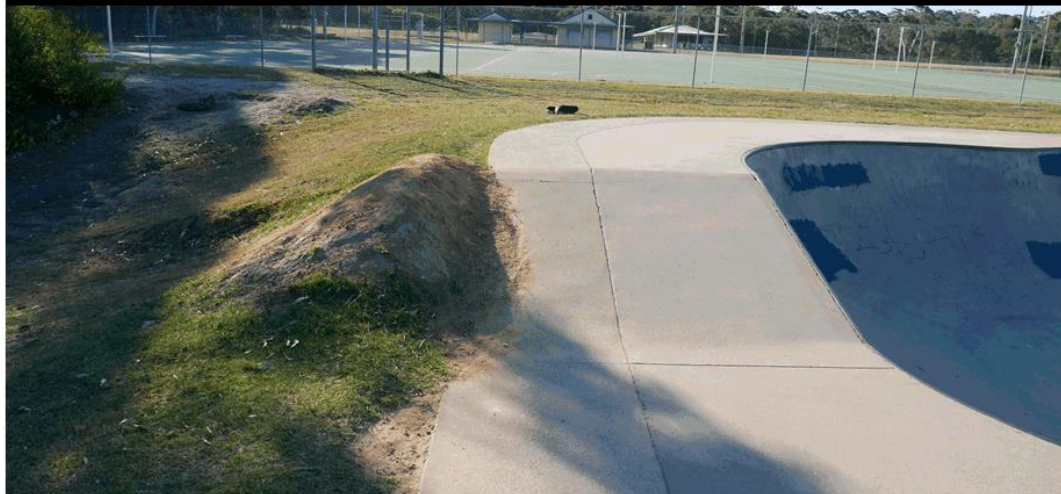
**USER MODIFICATIONS**

BMX users have created a fly out / step up jump out of the bowl. This indicates that there are insufficient features for BMX users to ride in the park. Furthermore, the dirt used to create the step up is spilling on to the skate surface, creating a rough riding surface for skateboard and scooter riders. A more permanent feature should be included for BMX riders, as well as regular maintenance undertaken to clean all skate surfaces.
