# Nowra CBD Revitalisation Strategy Committee

# 16 Berry Street Nowra

AKA Former Betta Electrical Building

Condition Assessment, Remediation Options & Potential Future Uses

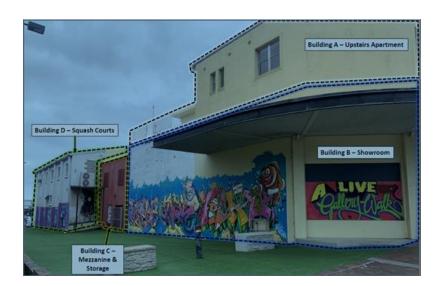
#### Current State - Internal Areas

- Hazardous Materials Assessment Report Undertaken Feb 2021 – Hygienist
- High / Medium Risk Issues Identified
  - Asbestos Containing Materials (ACM) ~ 750m²
  - Friable Asbestos Bldgs. C & D (high levels dust)
  - Bonded Asbestos Bldgs. A & B
  - Metallic (Lead) Paint & Dust Bldgs. B & D
  - · Light Fittings containing PCB's
  - · Floor lino containing SMF Bldg. A
  - · Biological Hazards, Pidgeon guano Bldg. A
  - Mould & water Ingress All Buildings

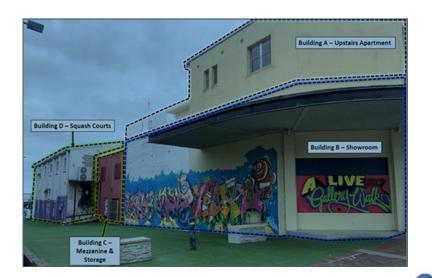
#### Current State - External Areas

- Hazardous Materials Assessment Report Undertaken May 2021 – Hygienist
- High Risk Issues Identified
  - Friable Asbestos Bldg. D (S6 Roofing) ~ 320m<sup>2</sup>
  - Asbestos Guttering
  - Roof Vents
  - Building Rubble subfloor Bldgs. B & D
- Note at time of testing
  - · No Airborne fibres detected in adjacent carpark or laneway
  - No Residual asbestos on the turf and around drain

- Heritage Issues Not Anticipated
- Neighbouring Properties Existing State
- Ephemeral Artwork
- Interim Future Use
- Ongoing Site Management
- Public Perception Derelict Assets
- The site must remain vacant, secure & inaccessible unless accompanied by Licensed Asbestos Assessor
- ACM should to be removed as soon as practical by appropriately licenced asbestos removalist
- Asbestos & Hazardous Signage affixed at points of entry
