Shoalhaven City Art Collection

PRESERVATION NEEDS ASSESSMENT

Kim Morris, September 2023

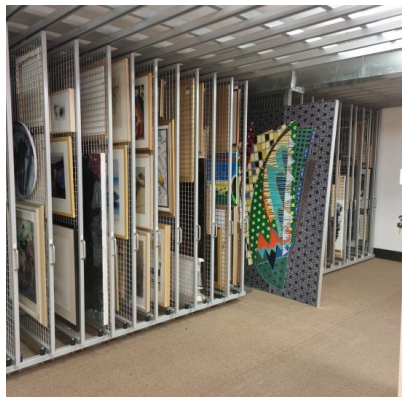
Light sources are very close to artworks housed at upper spaces or large enough to be close to the ceiling. The light sources emit no UV, but light intensity is very high and has the potential to fade light sensitive media through cumulative exposure.

Art Store screens

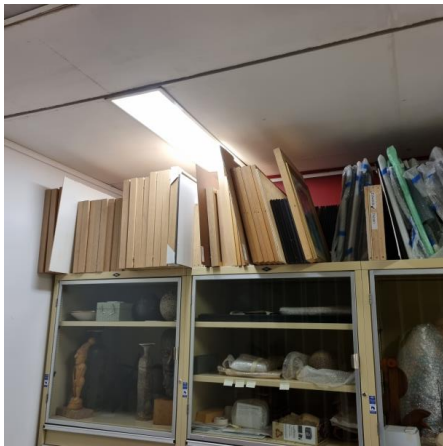
Lighting in close proximity to artworks on paper

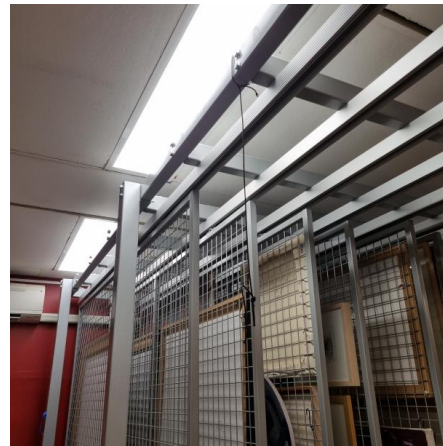
Lighting in close proximity to artworks on open storage

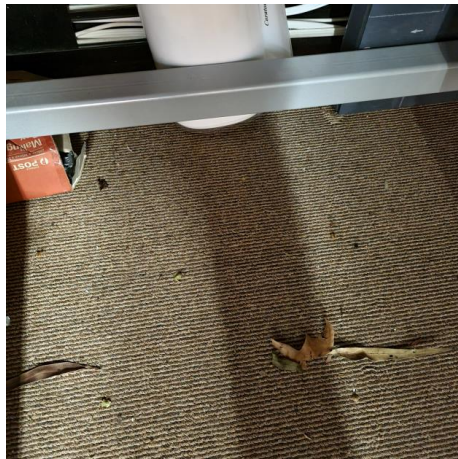
Dust holds moisture at an object's surface, thus increasing the localised relative humidity. It may also hold contaminants. This creates dust build-up on surfaces and promotes possible mould growth. Some moulds digest and stain the materials they colonise.

Dust and debris under and behind art screens

- The building seal be improved around all doors and windows
- The seal around the roof gutters be improved
- A regular maintenance cleaning program be maintained for work and storage spaces
- All artworks on open storage be cleaned to remove dust build-up
- Backing boards be added to canvas artworks

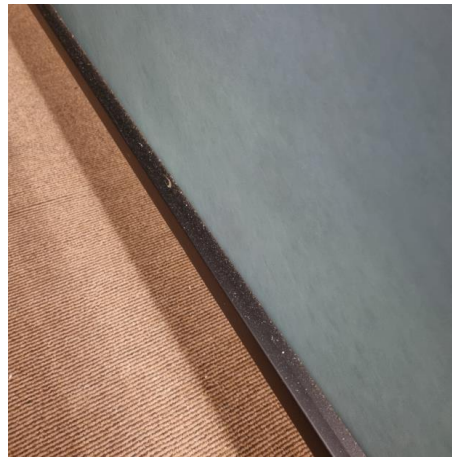
Dust and debris build-up on artwork surfaces
(works on open storage)

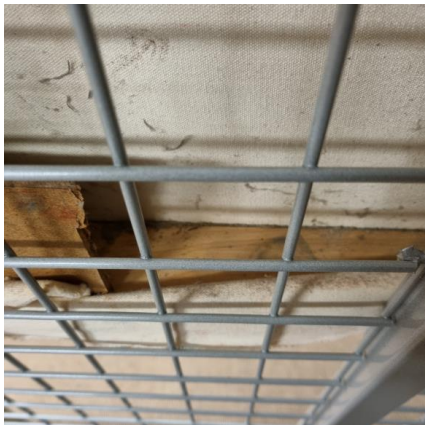
Dust build-up on artworks. Requires cleaning and backing board

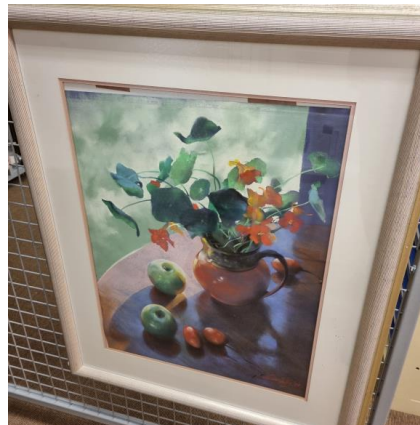
Failing mounts. All mounting required revision

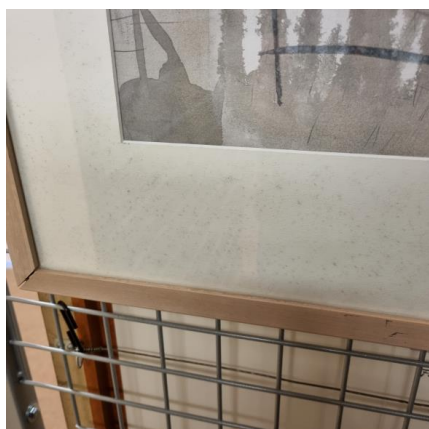
Foxed mounts require replacement

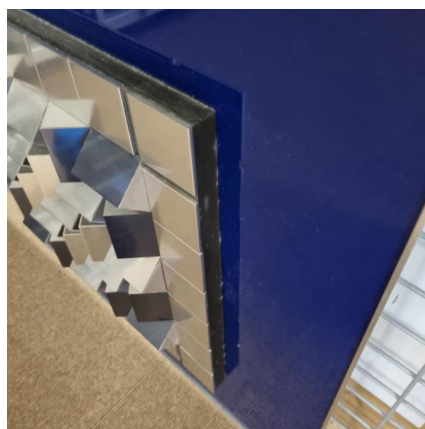
Mould growth on artwork: Requires cleaning

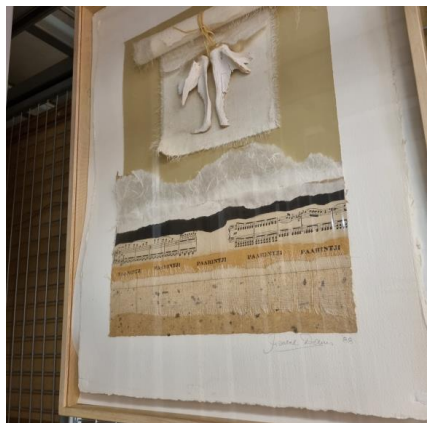
Collapsed mount

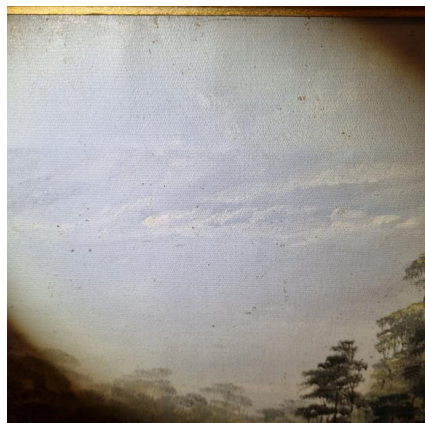
Louis Frank work: Required repair and surface cleaning

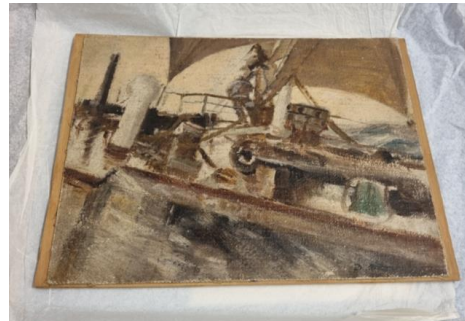
Denis Adams canvas. Items such as this
require better long term secondary housing
(sleeves Folders)

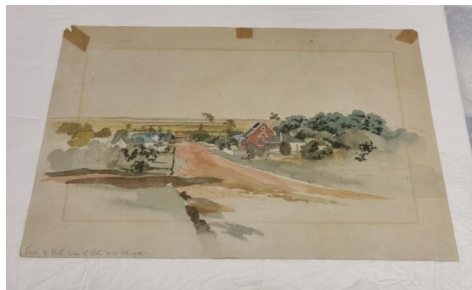
Tape stains and mat burn

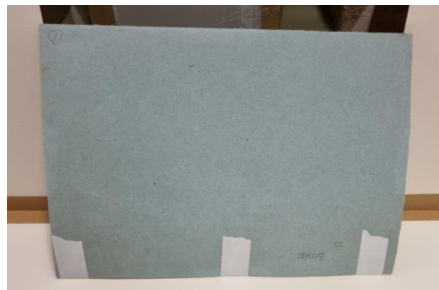
Poor-quality tape mounting tabs

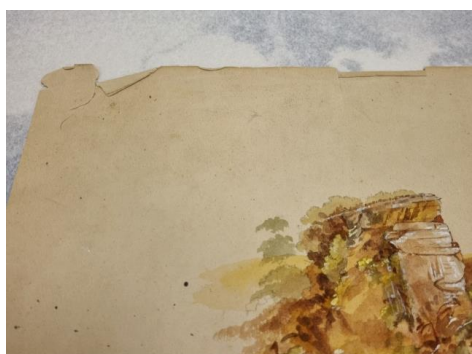
Untreated works require conservation repair

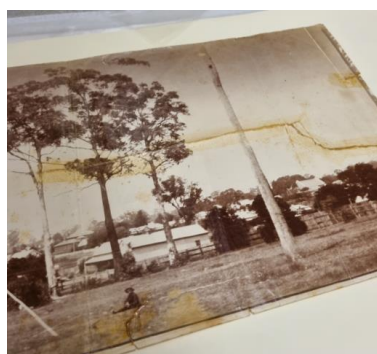
Original photographs have physical damage and tape stains

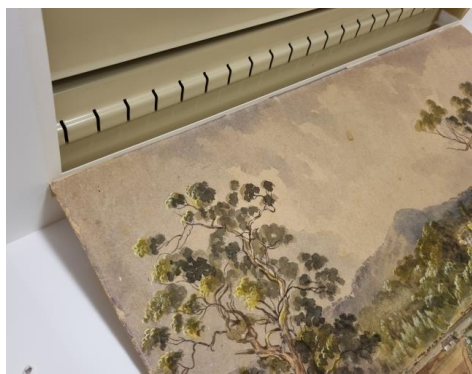
Many works are mounted to mat windows.
These should be re mounted to mount backings

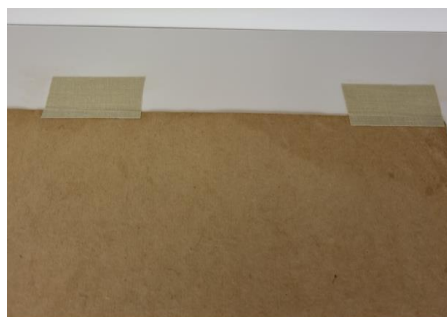
Poor quality mounting tapes have been used on many works. These require replacement

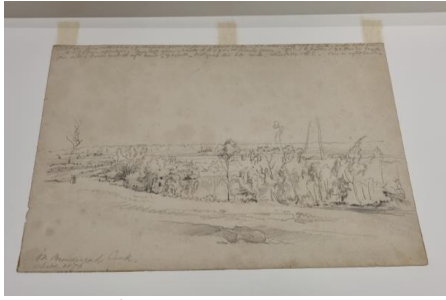
This style of mounting with conservation tissue tabs and wheat starch paste is acceptable. Some are failing.

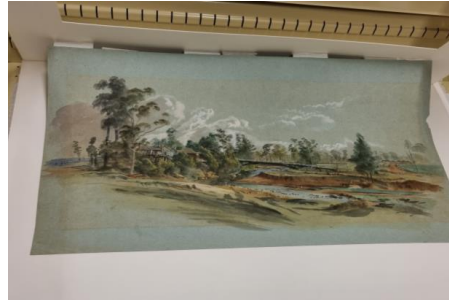
Failing mounting tabs are common on Elyard and other similarly mounted works

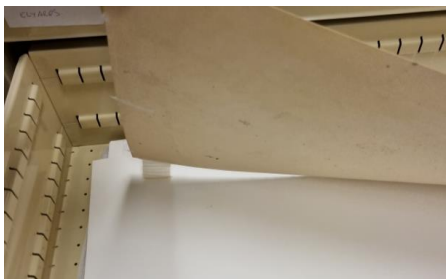
Failing tissue tabs

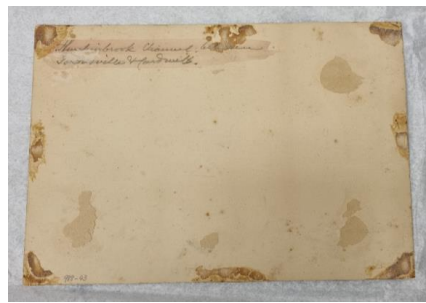
Untreated verso

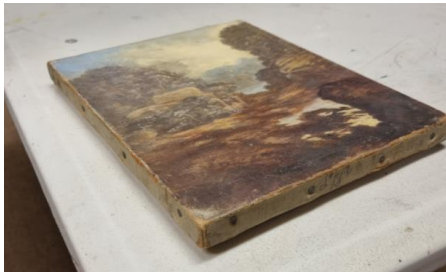
Small unframed paintings require box housing

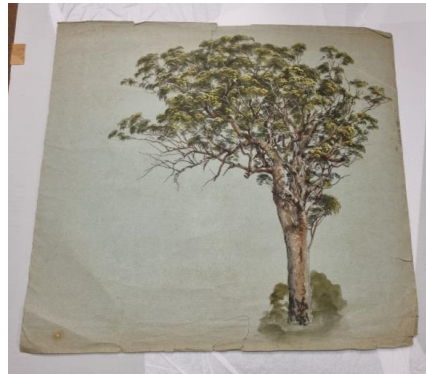
Untreated works require better protective housing and conservation treatment

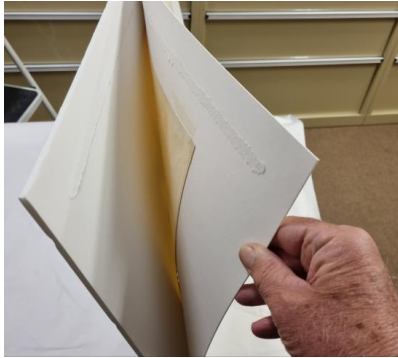
Some framed works are mounted against foam core board. Mounted with double sided taped. These require remounting with an acid free mount backing

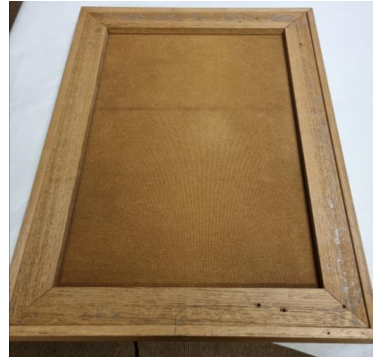
Several Elyard frames use plywood backings. These require replacement with acid free board

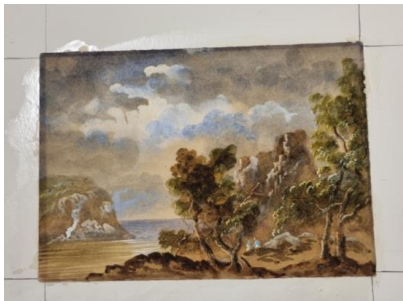
Some newer acquisitions are glued to mounts with PVA. These require conservation treatment to remove them

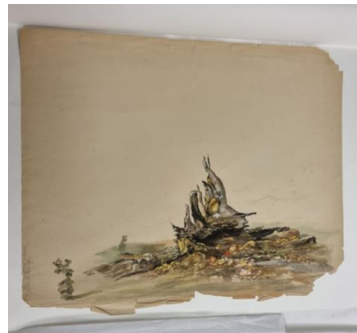
Untreated work requires conservation treatment

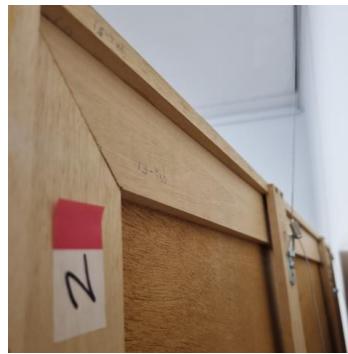
Some larger framed house poorly secured works boards and glazing. Revise

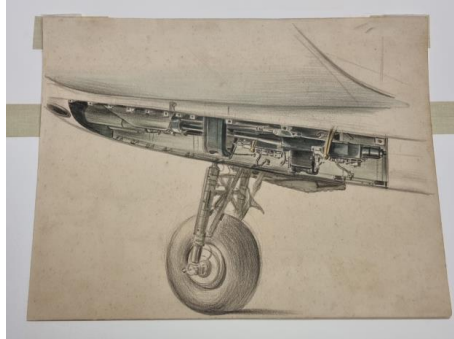
Mounted works by Payne have similar mounting problems to other mounted works

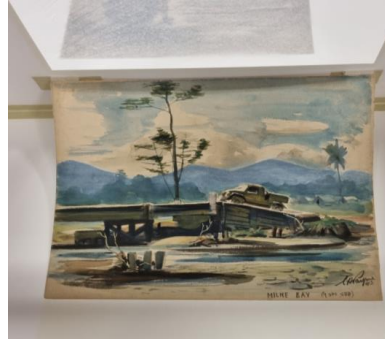
Failing mount tabs
