Shoalhaven Heads Estuary Taskforce

River Road Foreshore Management

UNSW
Water Research
Laboratory

Overview of WRL Report

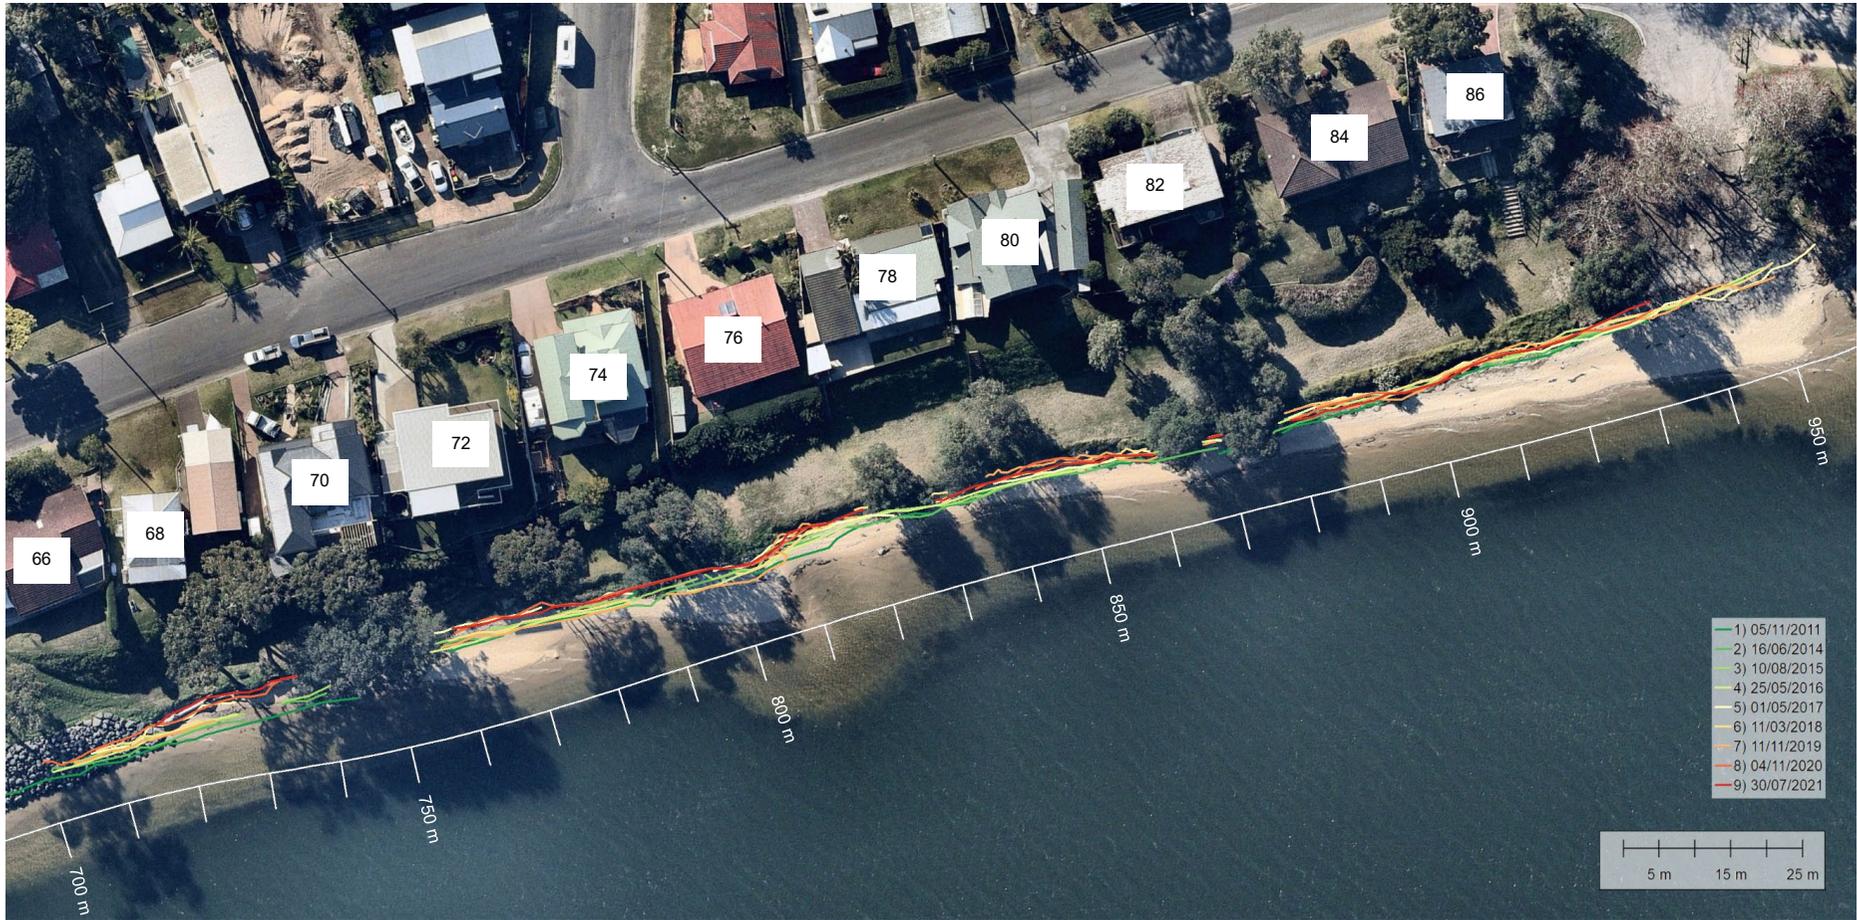
Bank toe alignment, 2011-2021

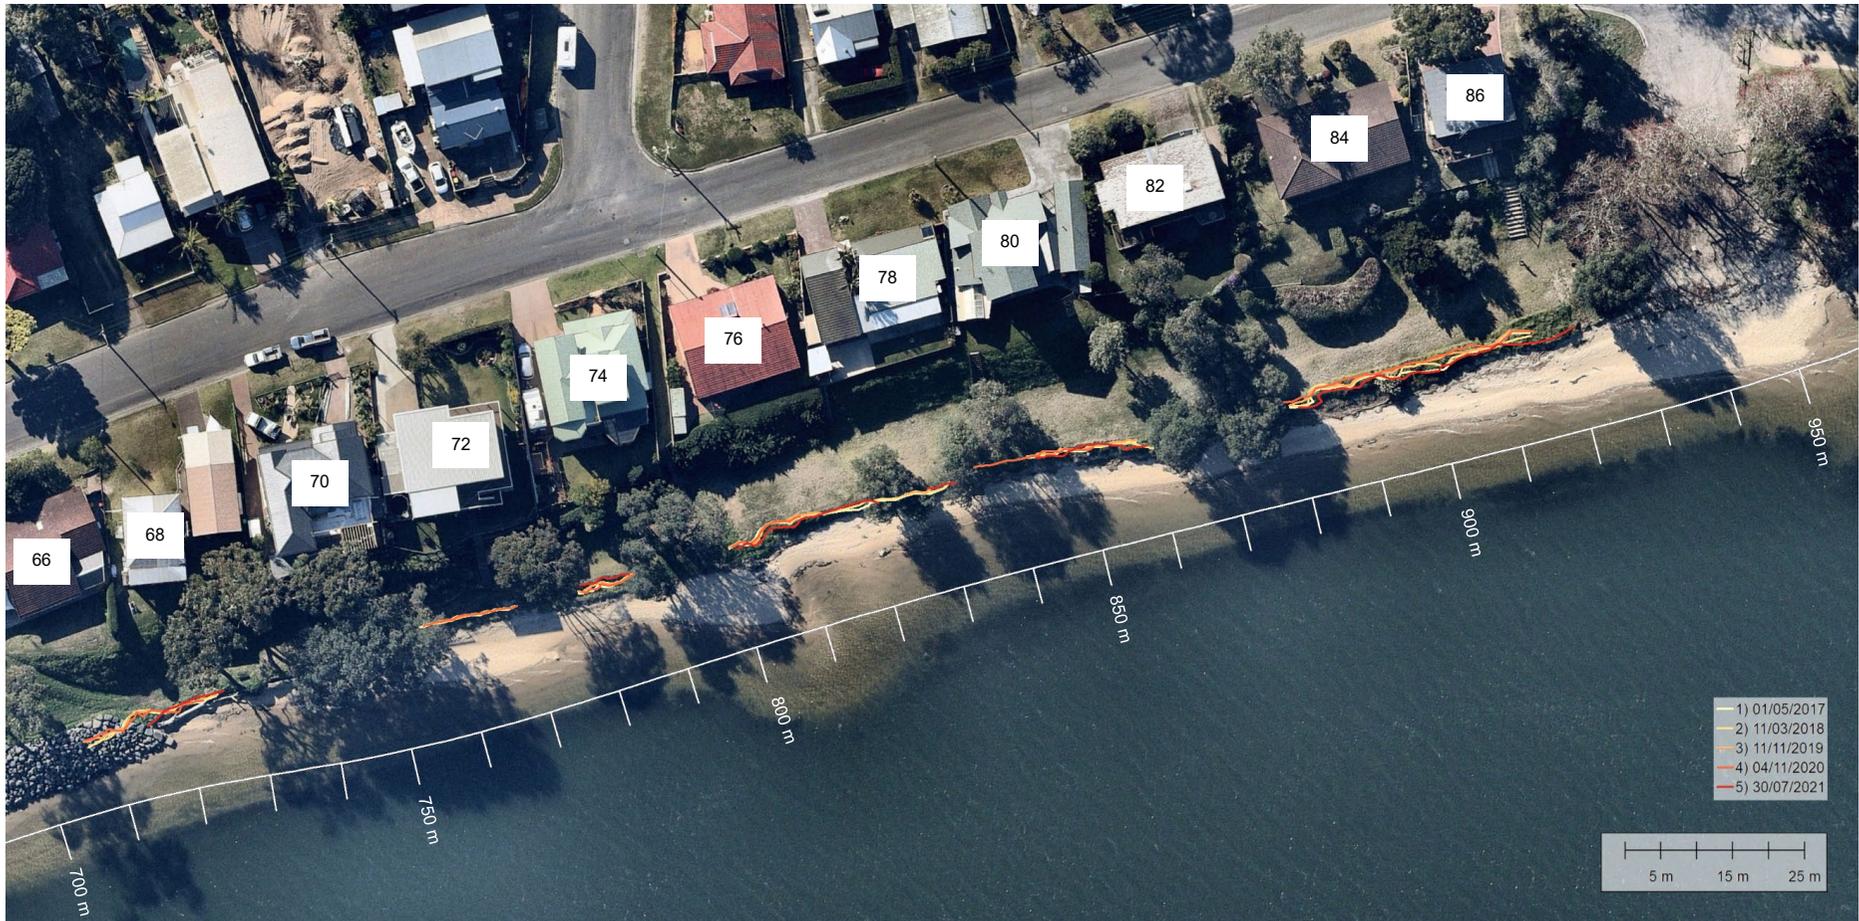
Bank crest alignment, 2017-2021

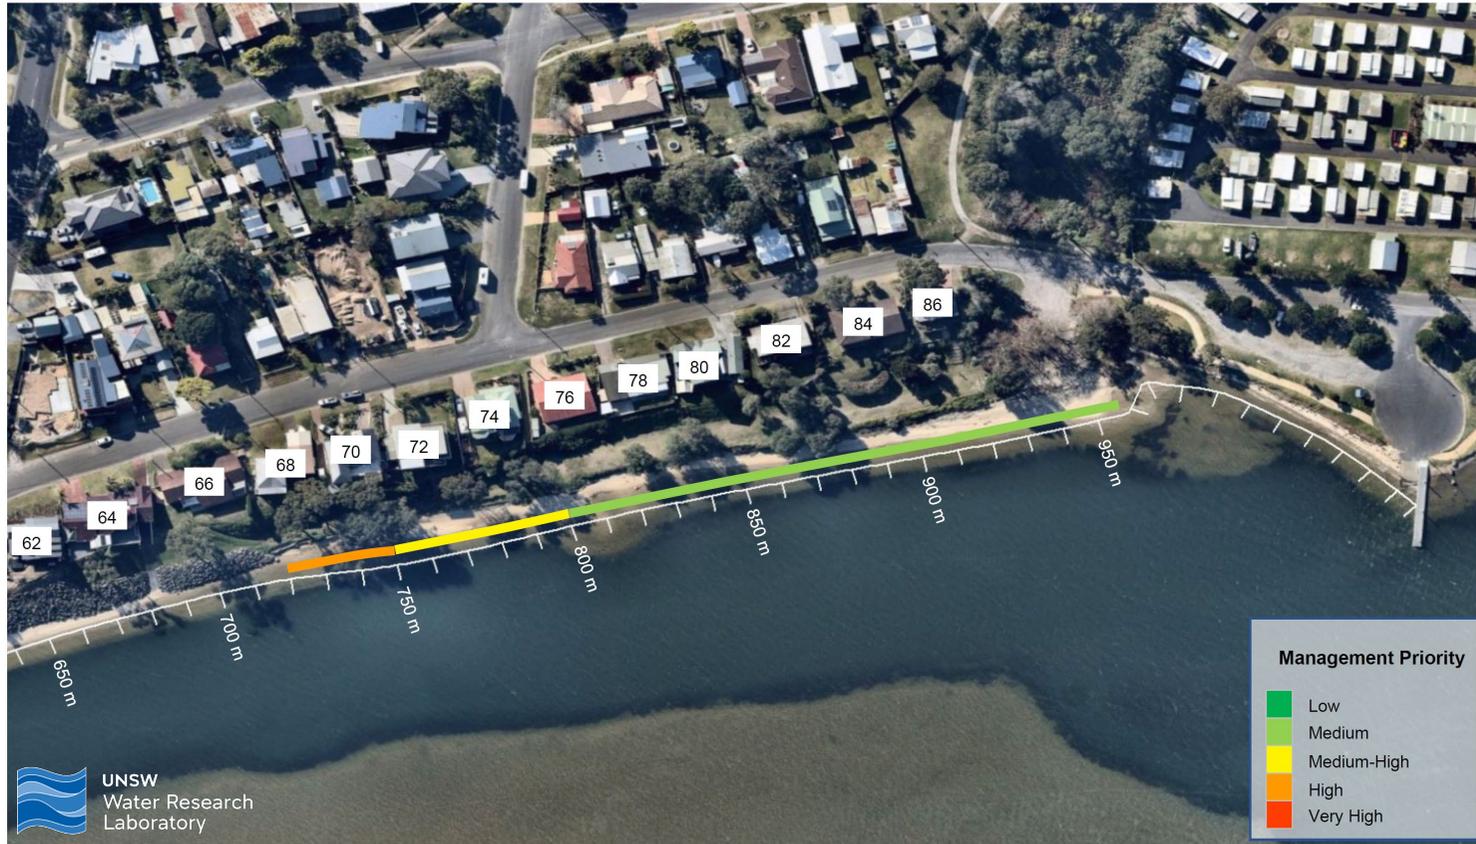
Figure 4.16 Study area and updated 2021 management priority

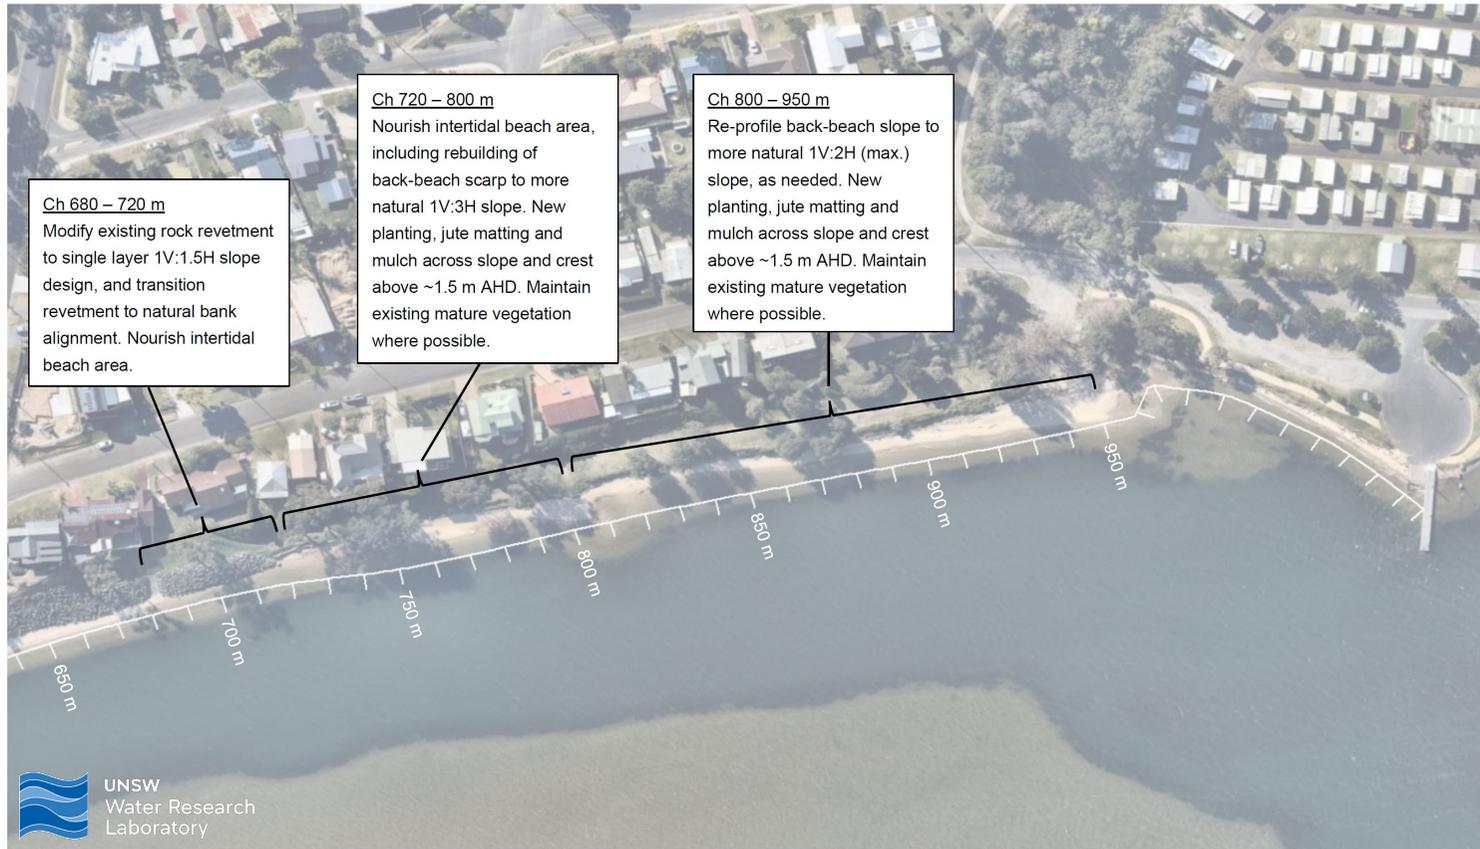
Figure 5.1 Overview of recommended management works

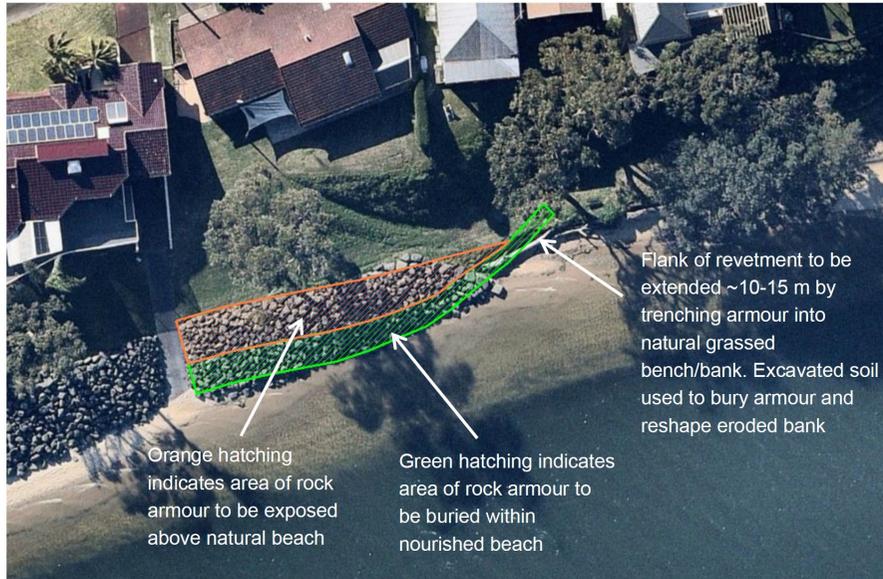
Figure 5.6 Indicative modified revetment concept alignment

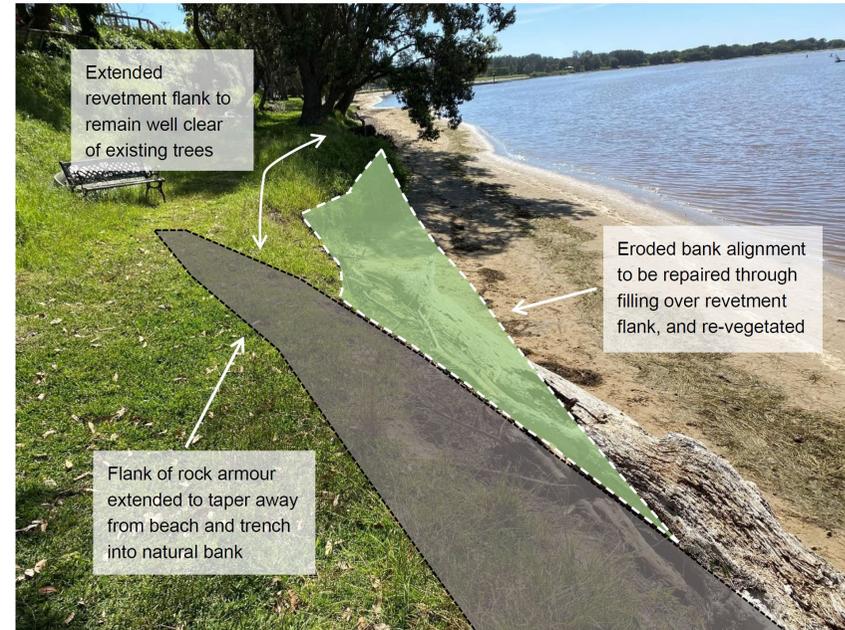
Figure 5.7 Indicative modified revetment flank concept alignment

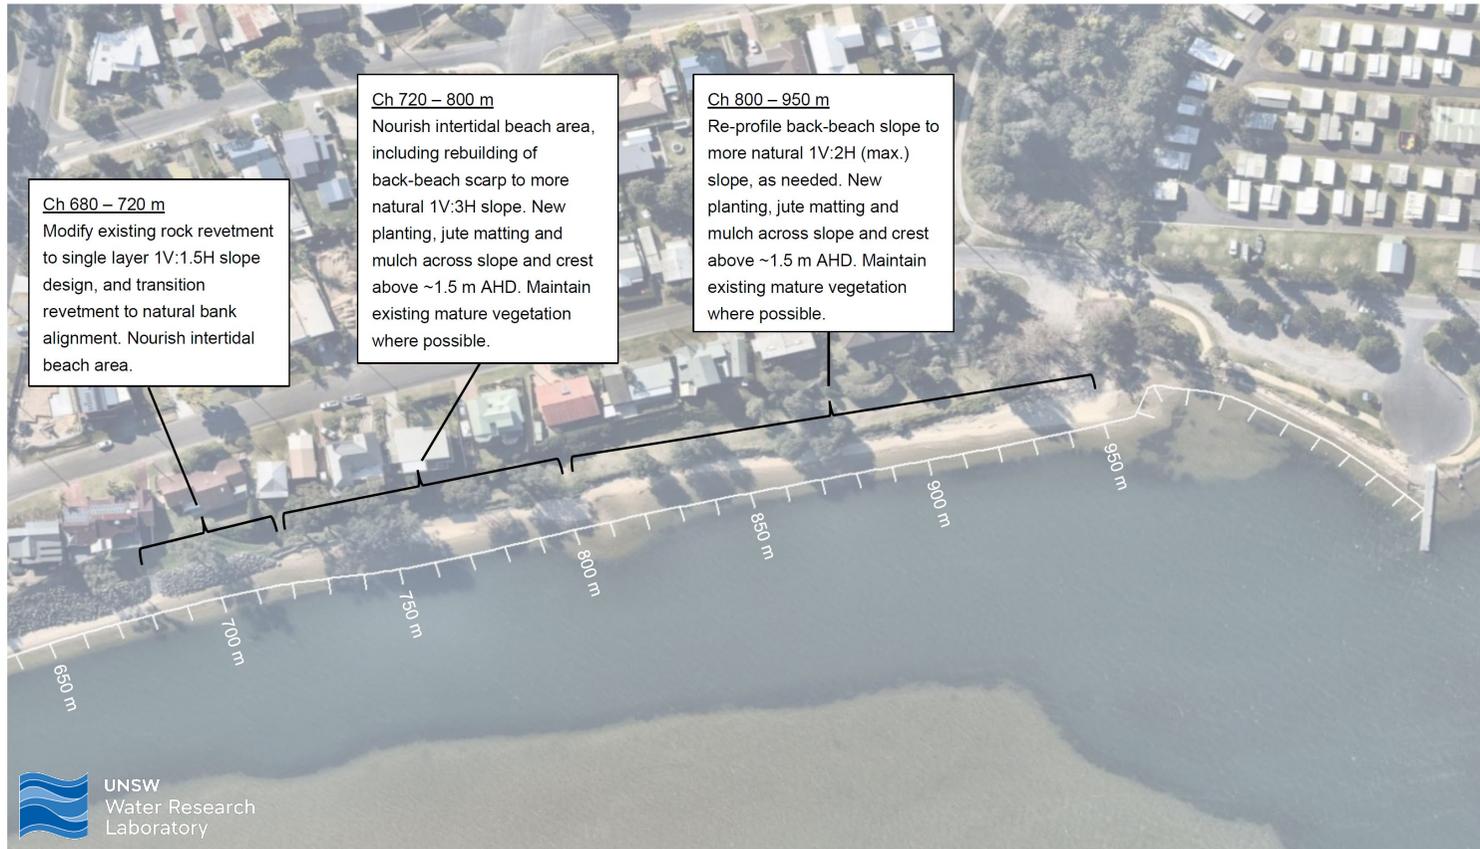
Figure 5.1 Overview of recommended management works
